Test Report **No.:** **64.190.23.0406.01-00**
Dated: **2023-08-02**

Applicant: Grupo Prisma Pro
Address: Camí Vereda, 25, 46469 Beniparrell,
 València, Spain
Sample Submission: The sample was submitted by applicant and identified.
Product Name: Aluminum Alloy Spigot Truss 铝合金插销桁架
Order No.: /
Identification/Style No.: VKSST
Manufacturer: Grupo Prisma Pro
Country of Origin: /
Buyer: /
Export to: /
Receipt Date of Sample: 2023-07-27
Date of Testing: From 2023-07-27 to 2023-07-28
Test Result: Refer to the data listed in following pages

1. Loading test according to client's requirements

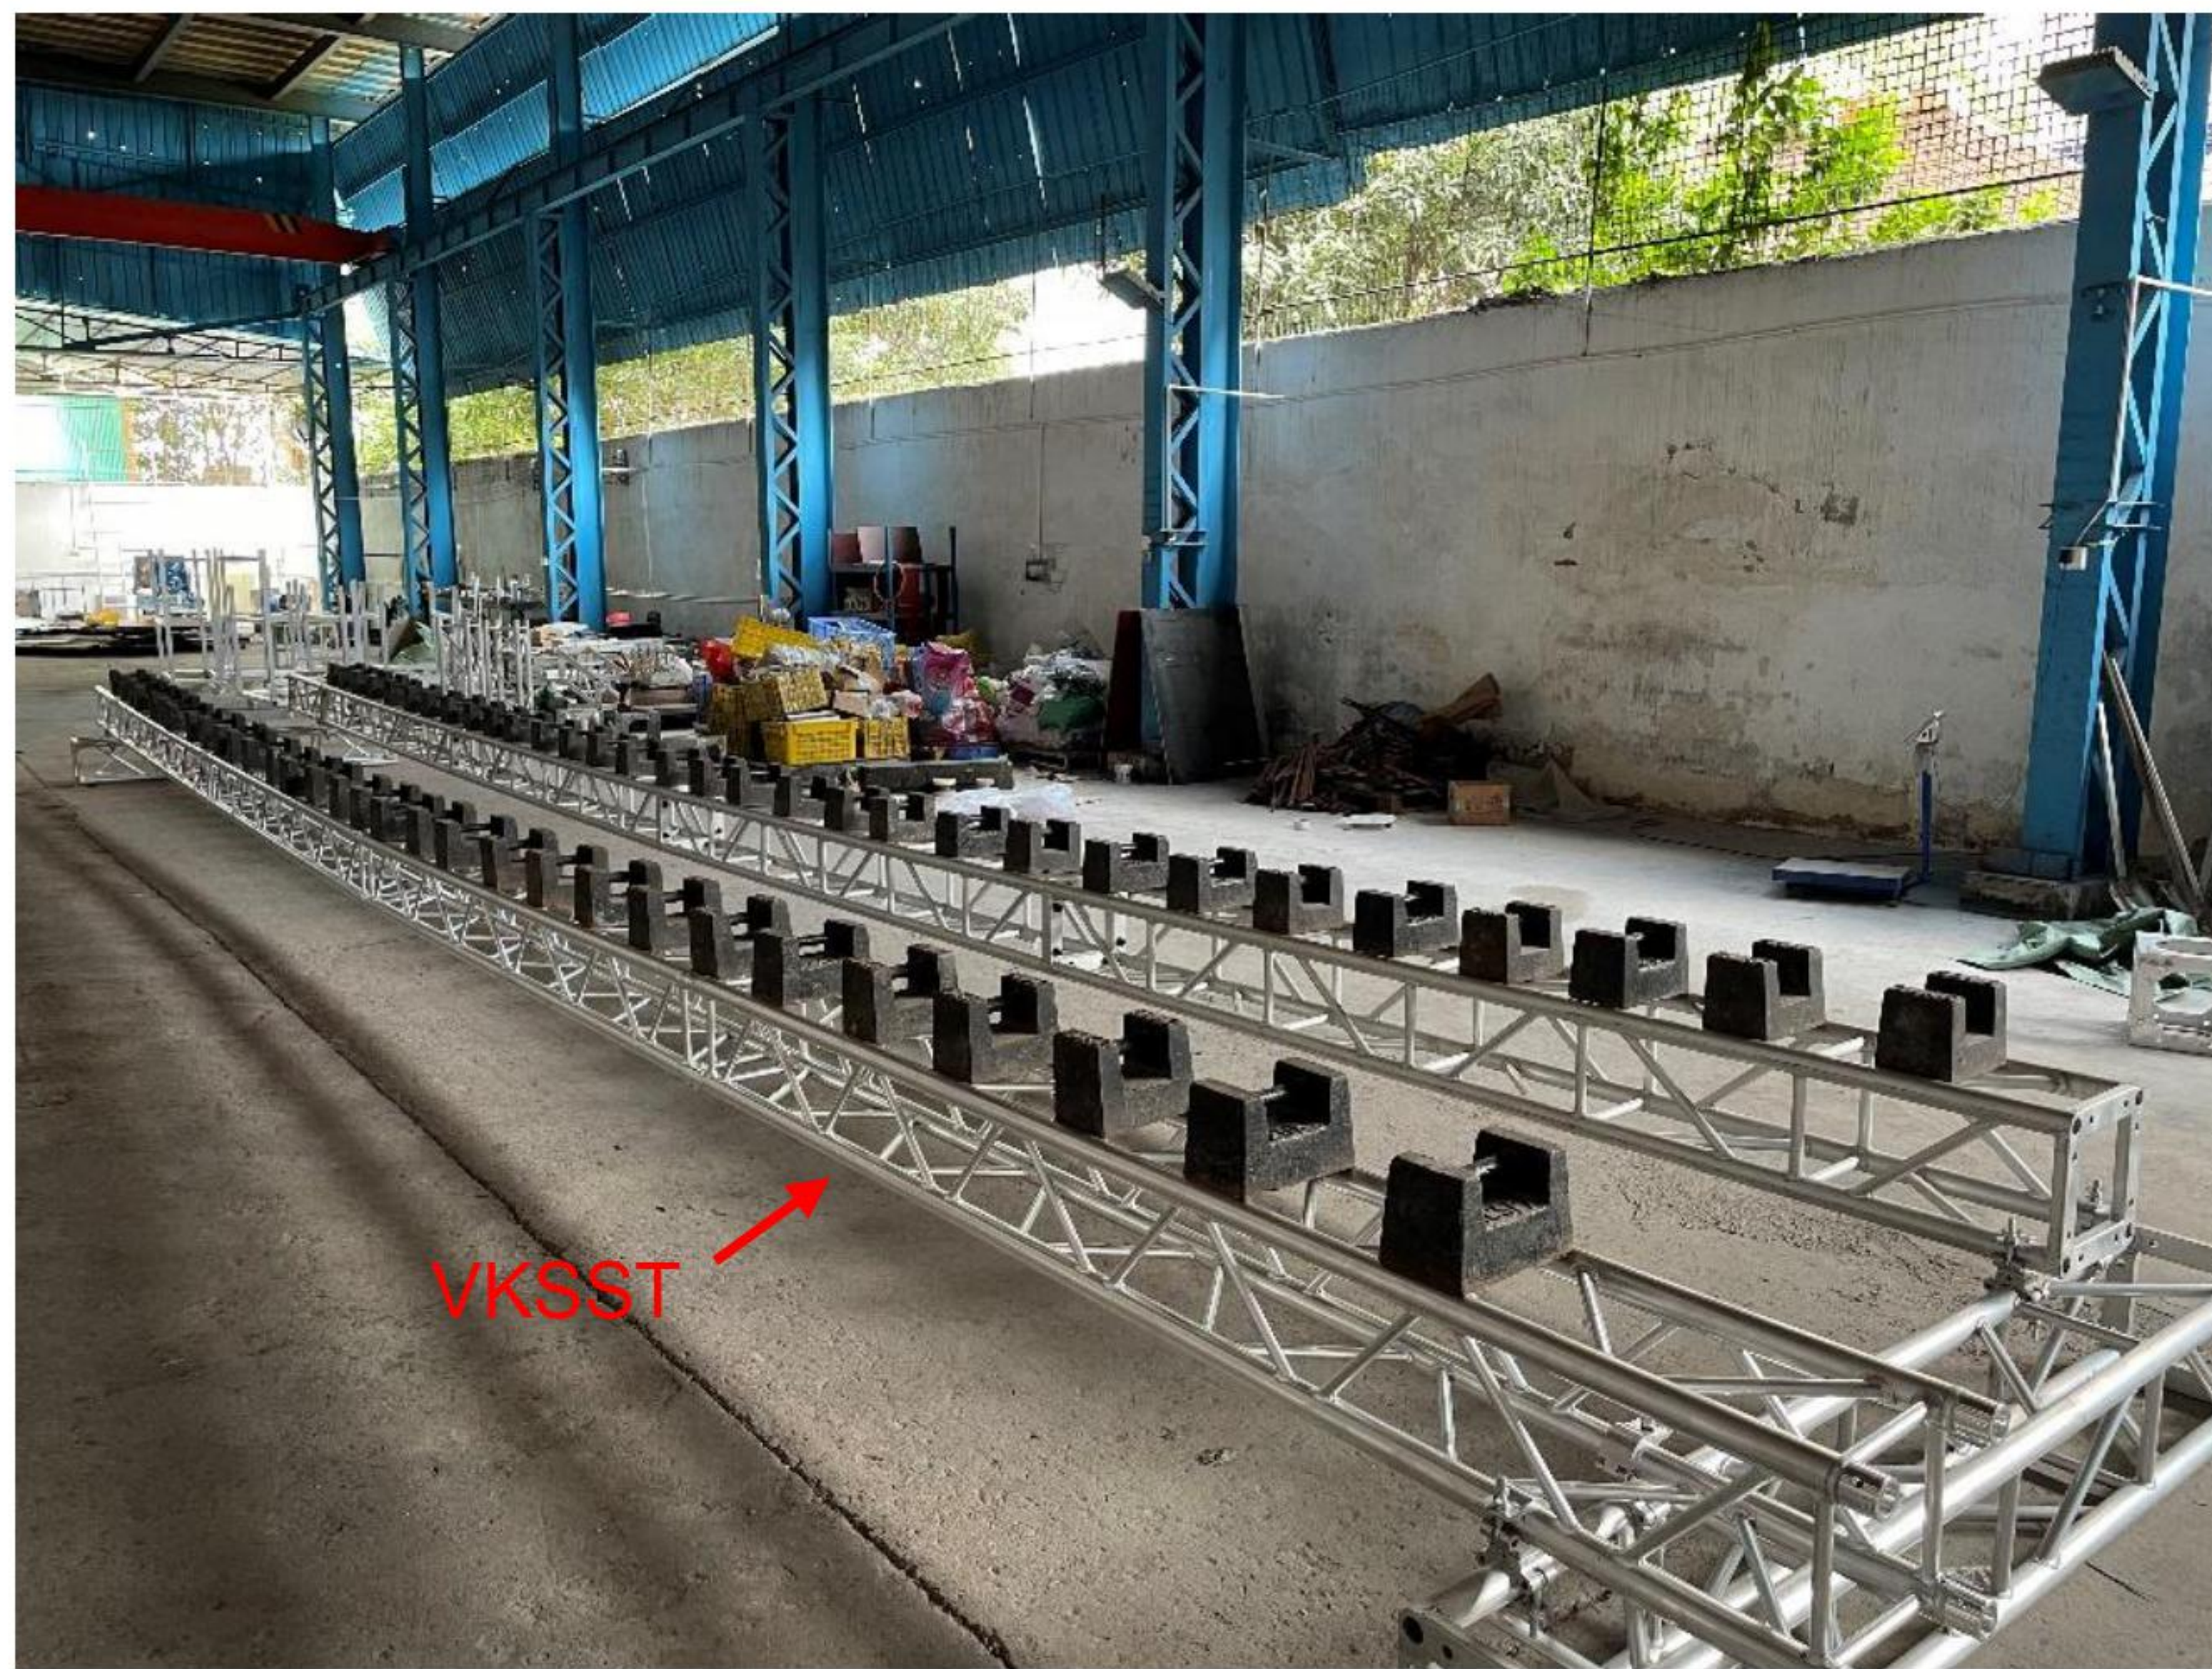
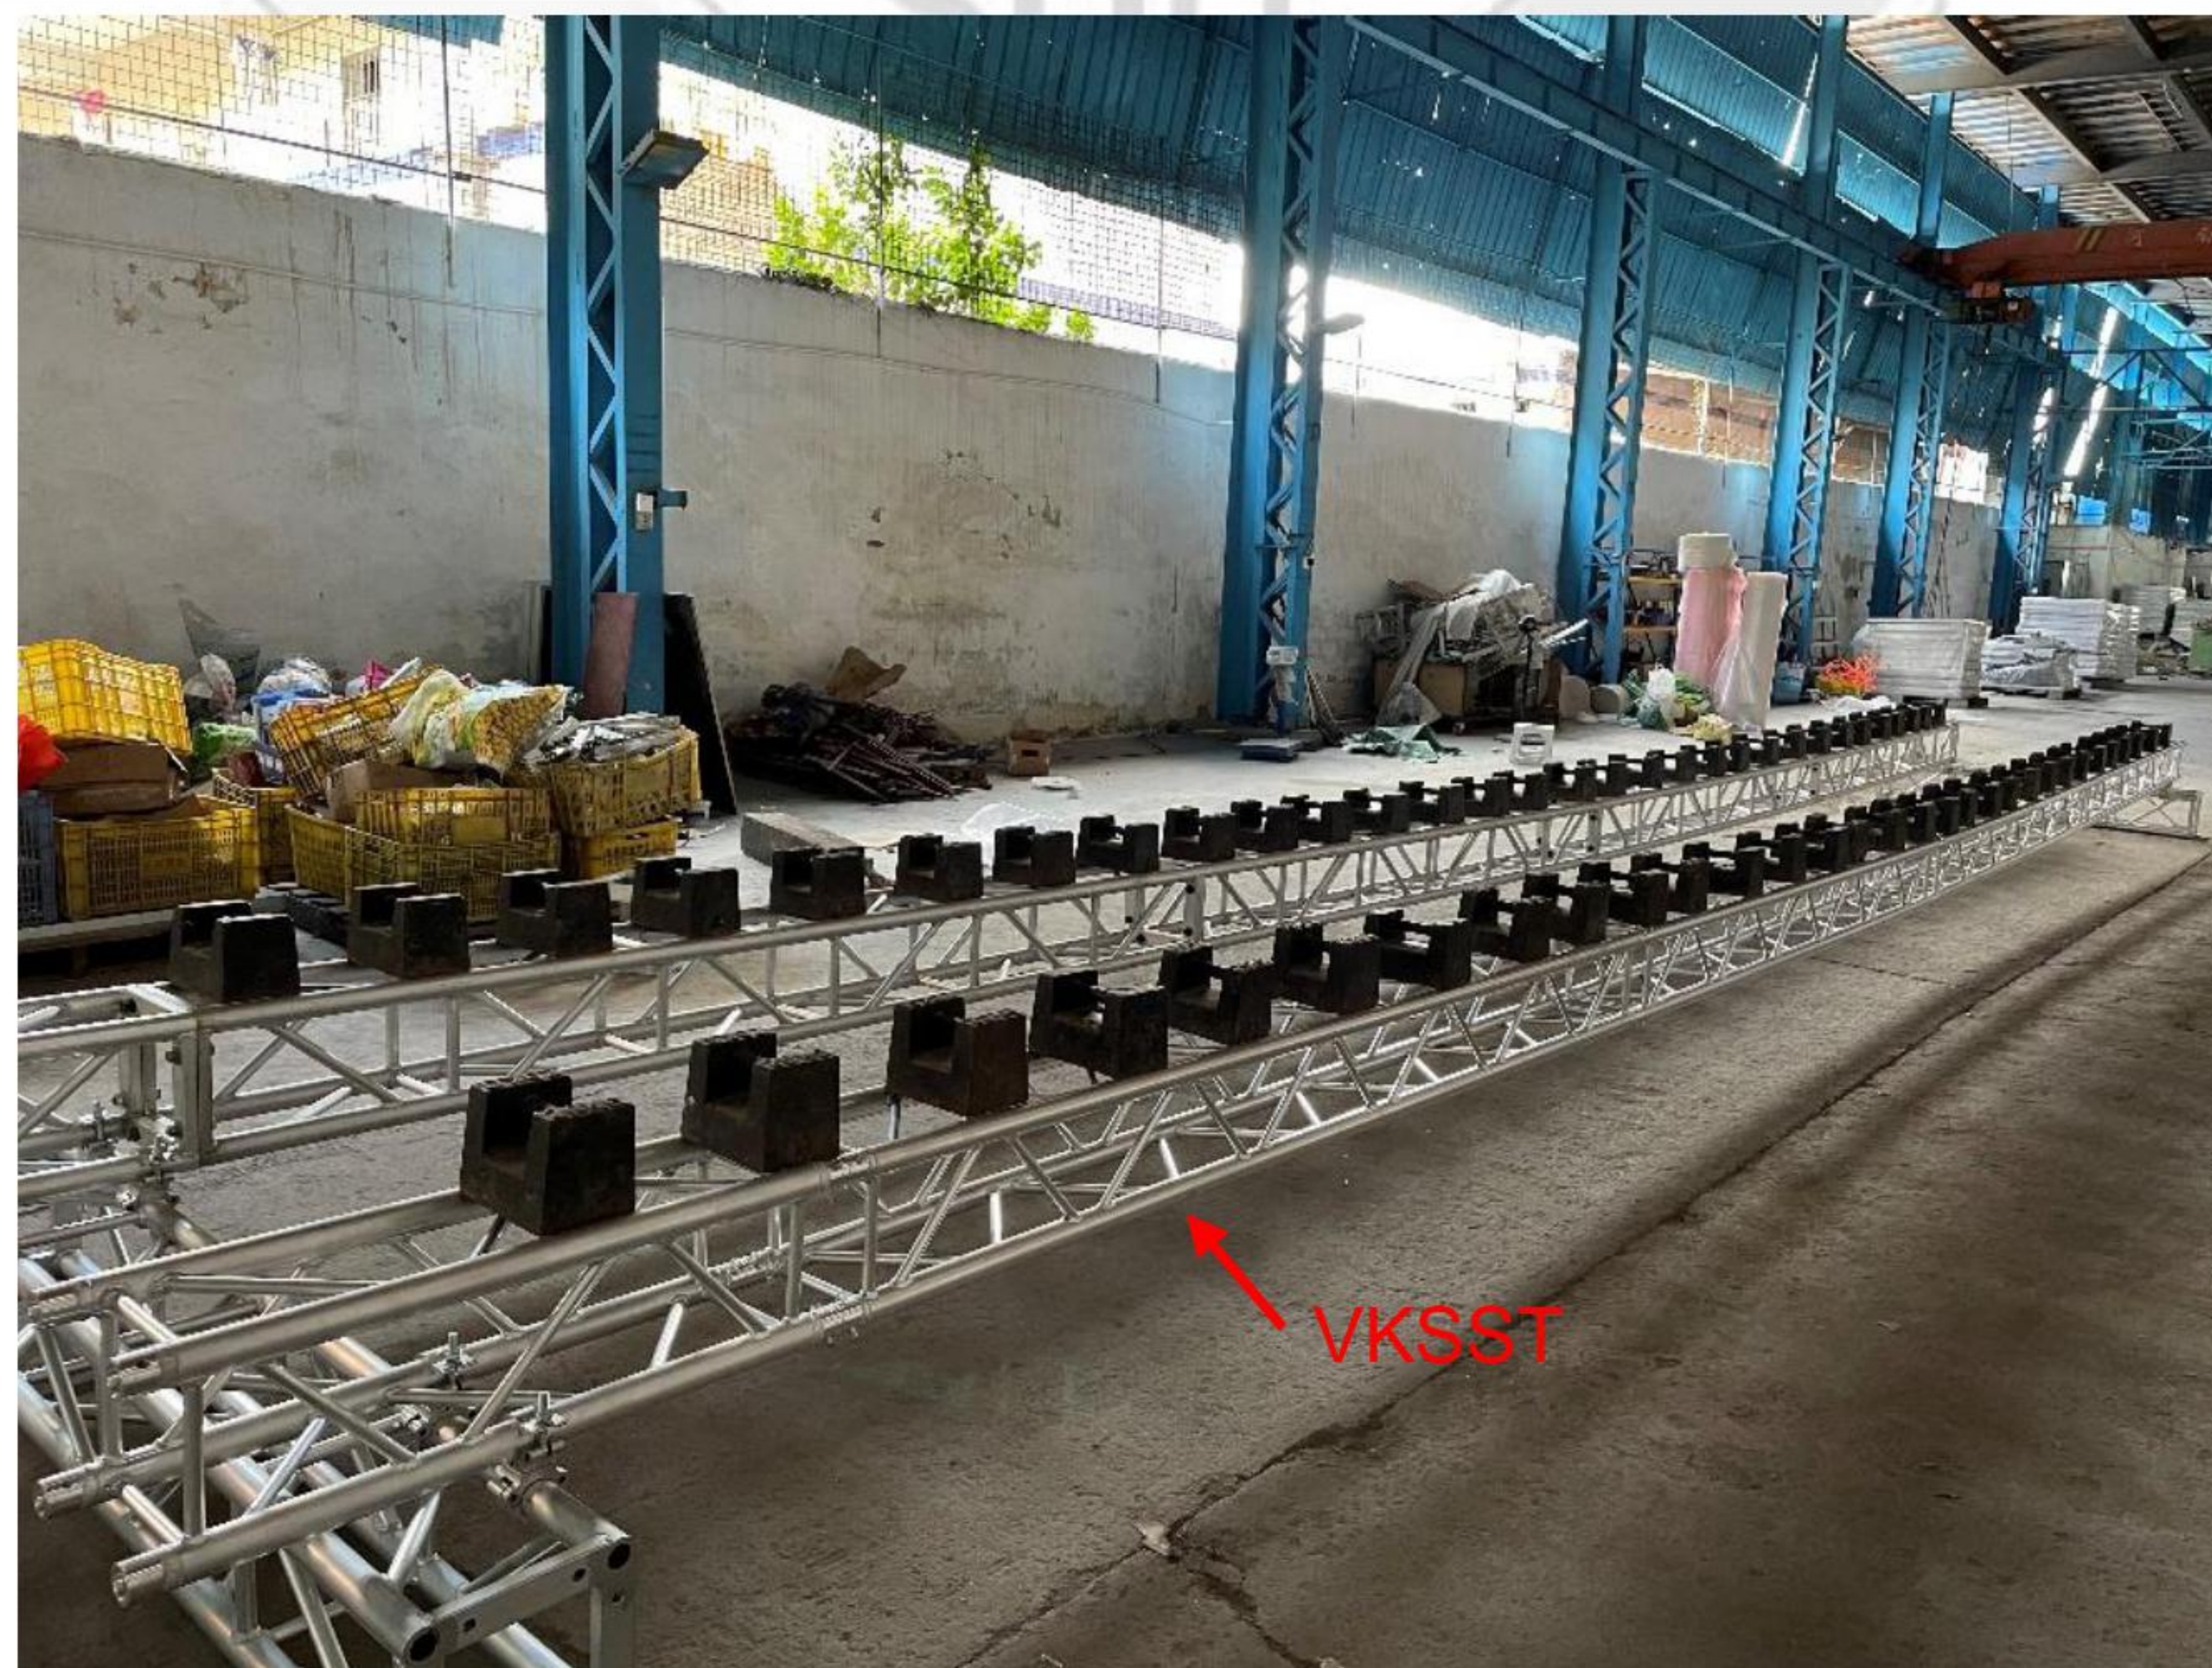
Sample/test photo(s)

1	Product Description	Aluminum Alloy Spigot Truss 铝合金插销桁架	
		Main tube (mm):	Dia. 50 x T 3.0
		Supporting tube (mm):	Dia. 20 x T 2.0

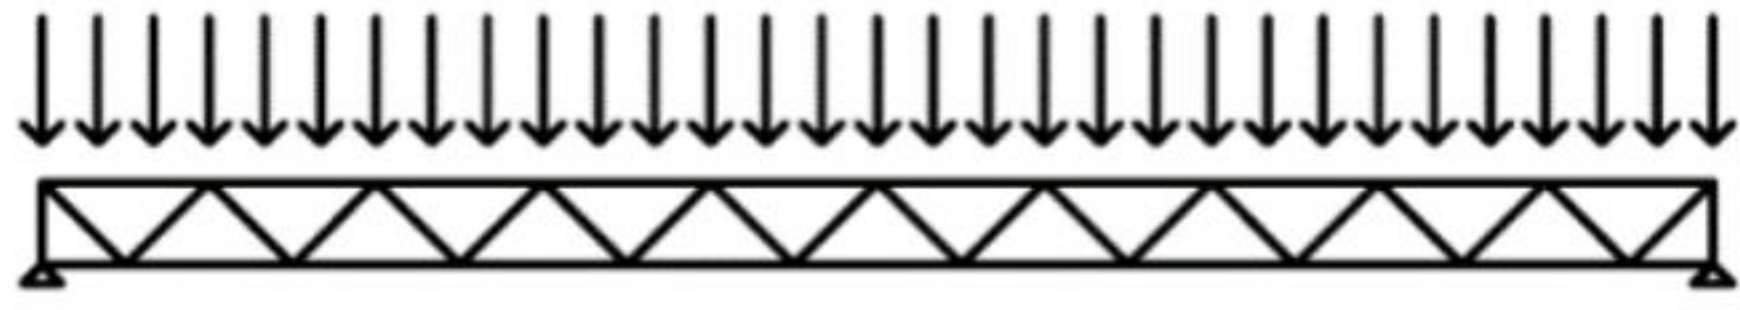
<p style="text-align: center;">Figure 1</p>	<p>Test loads: 620kg Test duration: 30min Span: 12m</p> <p>No obvious damage was found after test.</p>	/

Test item	Requirement ~ Test	Measuring result ~ Remark	Verdict
Loading test	<p>The tested loads 620kg were applied and the deflections were measured before and after 30min test. Uniformly distributed load (UDL) The truss was supported by two rigid frames at two ends to reach a certain span tested according to Figure 1. Then the specified nominal load was uniformly distributed on the truss. Measured the deflection of central point. Check if any damage during and after test.</p> <p style="text-align: center;">Load</p>

Item	Test Data
Span, (m)	12
Uniformly distributed load, (kg)	620
Distance from bottom of truss to the ground before loading test, (mm)	360
Distance from bottom of truss to the ground in loading test(30min), (mm)	265
Distance from bottom of truss to the ground after removing test loading, (mm)	353
Measured deflection, (mm)	95
Residual deflection, (mm)	7
