# Test Report

No.: 64.190.24.3110.01-00

**Applicant:** Grupo Prisma Pro  
**Address:** Camí Vereda, 25, 46469 Beniparrell, València, Spain  
**Sample Submission:** The sample was submitted by applicant and identified.  
**Product Name:** Aluminum Alloy Barrier 铝合金护栏  
**Order No.:** /  
**Identification/Style No.:** VKSB  
**Manufacturer:** Grupo Prisma Pro  
**Country of Origin:** /  
**Buyer:** /  
**Export to:** /  
**Receipt Date of Sample:** 2024-10-30  
**Date of Testing:** From 2024-10-30 to 2020-11-06  
**Test Result:** Refer to the data listed in following pages

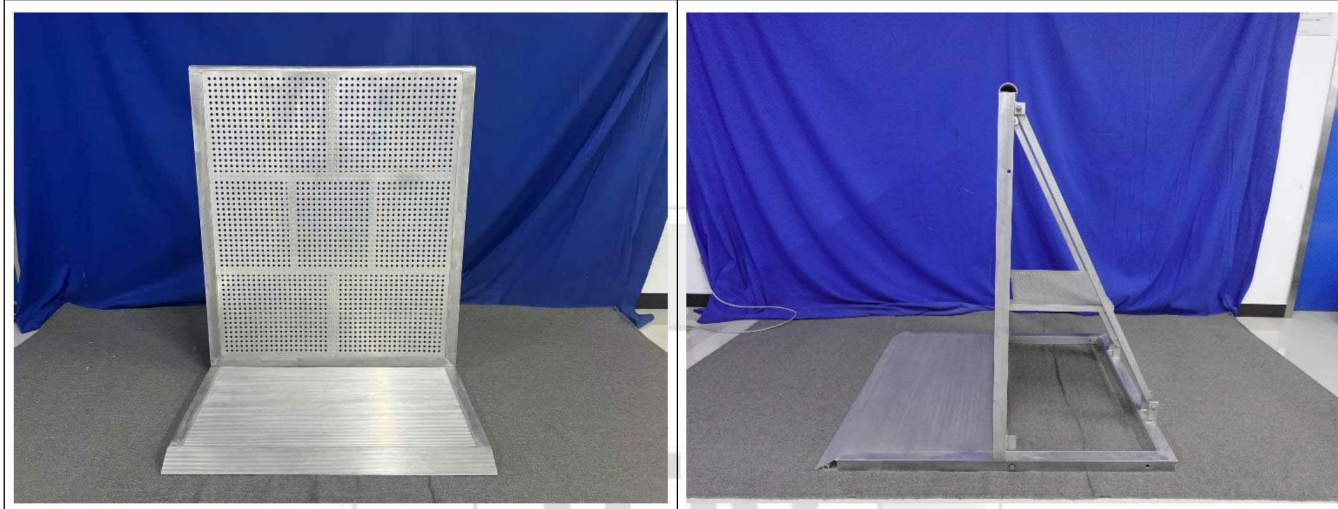
## Sample photo(s)

| 1 | Product Description | Aluminum Alloy Barrier 铝合金护栏 | |
| 2 | Dimensions | Overall Dimension: | L1200mm x W1000mm x H1200mm |
| | | Weight (kg): | 22.6 |

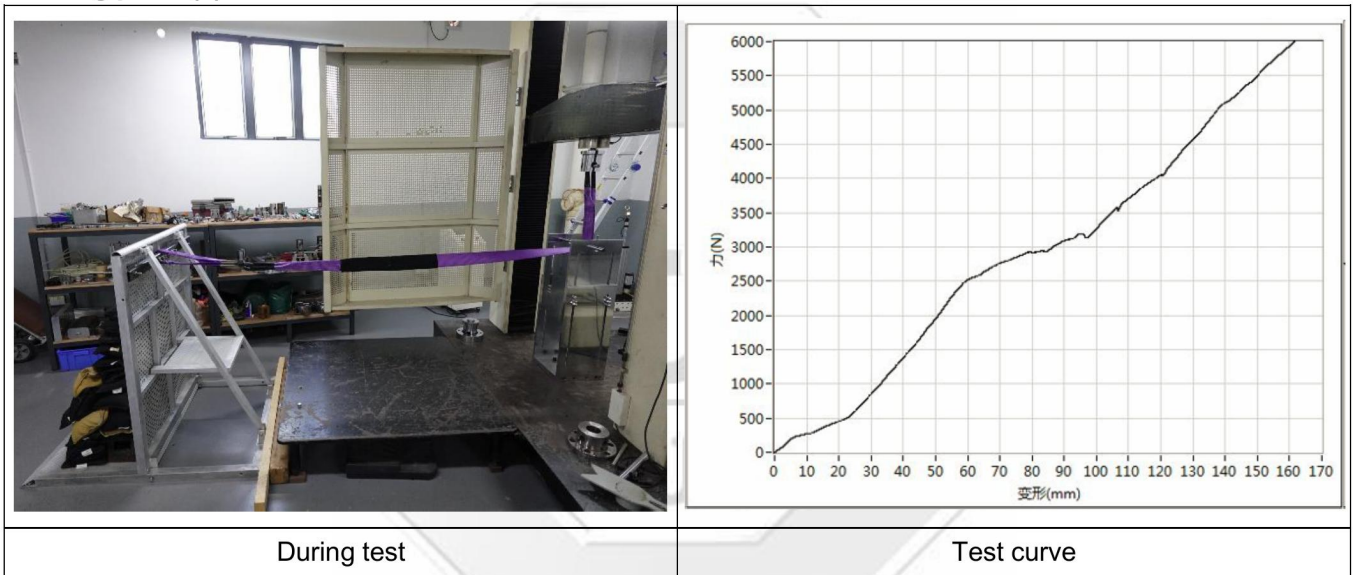
**Testing photo(s):**

| Test item | Requirement ~ Test | Measuring result ~ Remark | Verdict |
|---|---|---|---|
| Tensile test | A suitable clamp is used to fixed the product firmly to the test machine;<br>Apply a tensile force of 6000N to the product.<br>Start the test machine with the rate of 100 mm per minute;<br>Observe the product damage or not during and after test. | No visible damage was found during and after the test. | / |
