Test Report No.: 64.190.23.0404.01-00

Product Name: Aluminum Alloy Simple Stage 铝合金四柱舞台

Test Specification(s) or Test Item(s):

1. Loading test according to client's requirements

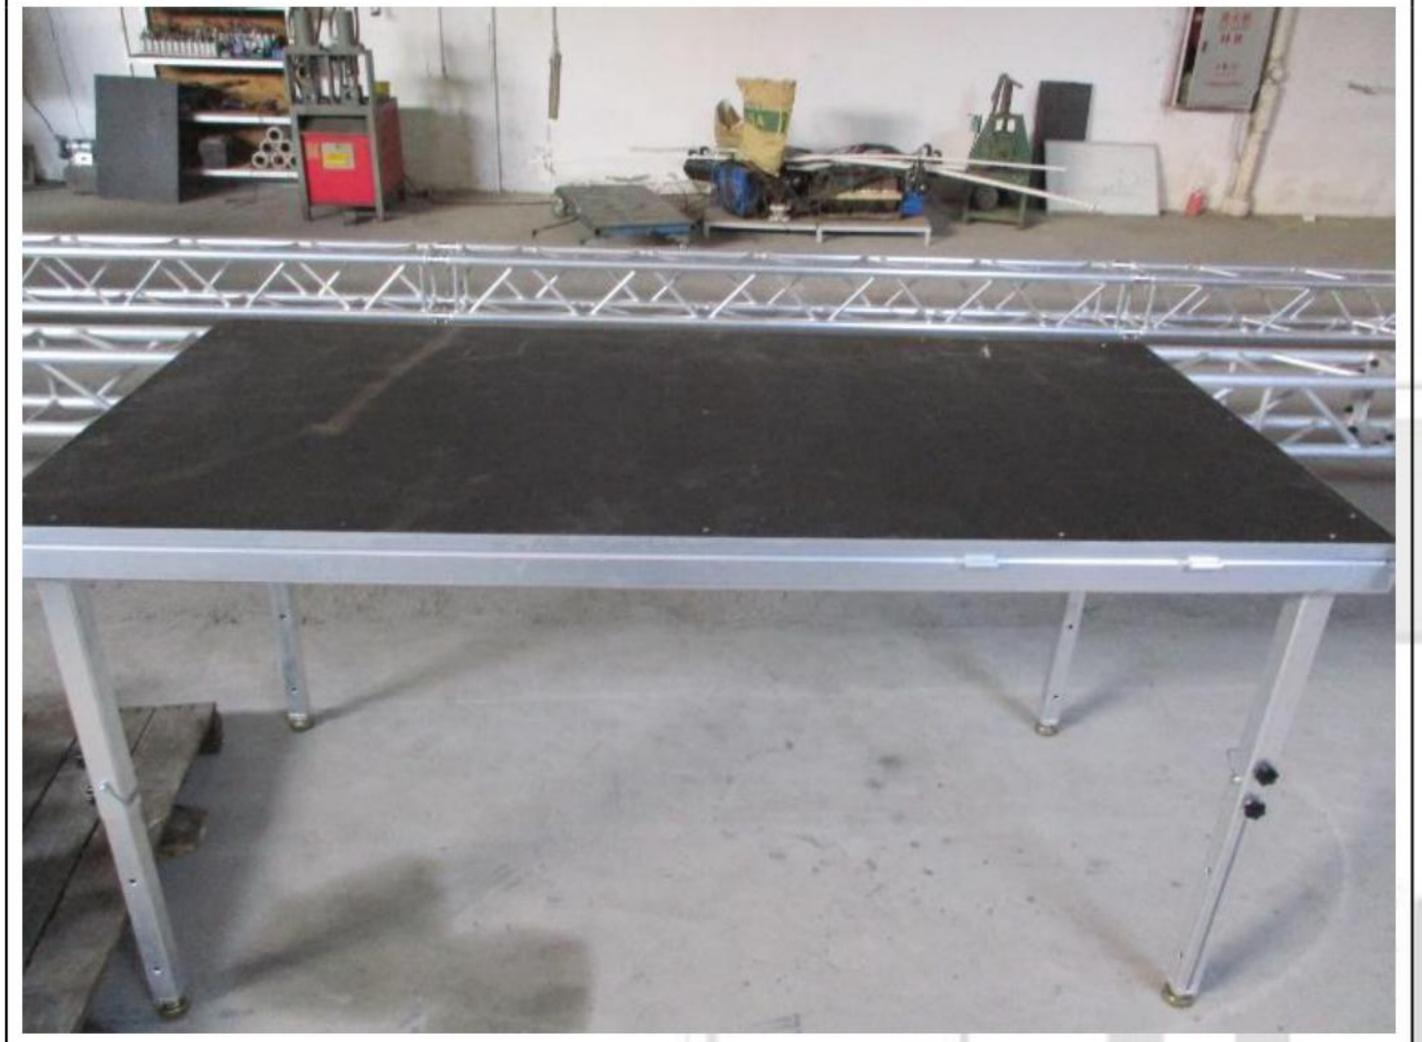
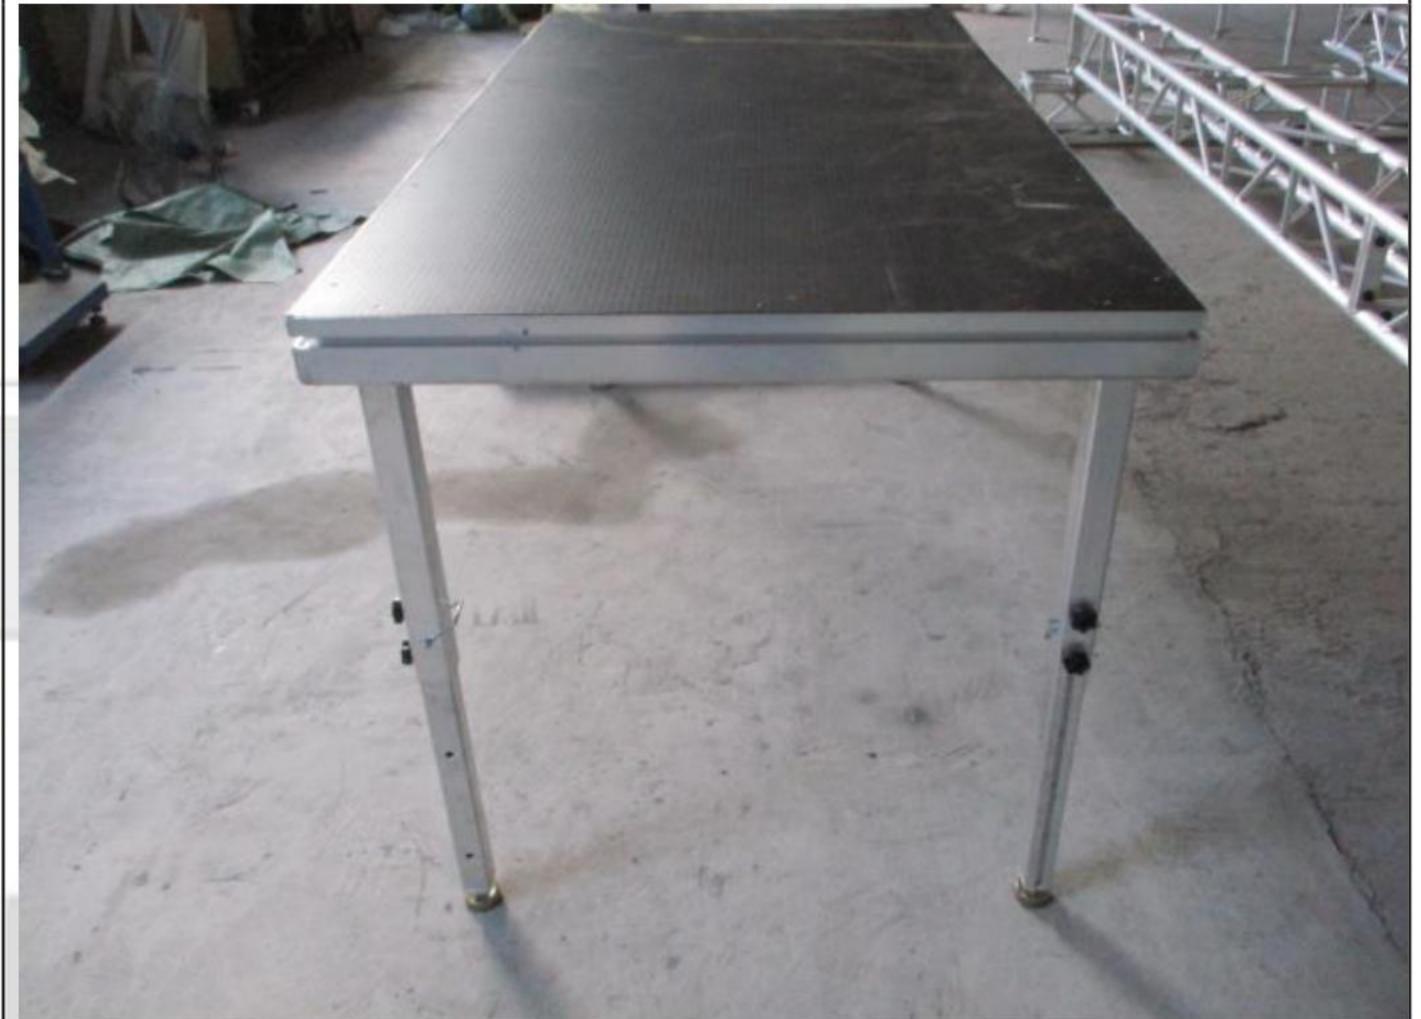
1 Product Description	Aluminum Alloy Sim	Aluminum Alloy Simple Stage 铝合金四柱舞台	
	Overall Dimension(m):	L1 x W2 x H1	
	Weight (kg):	39.15

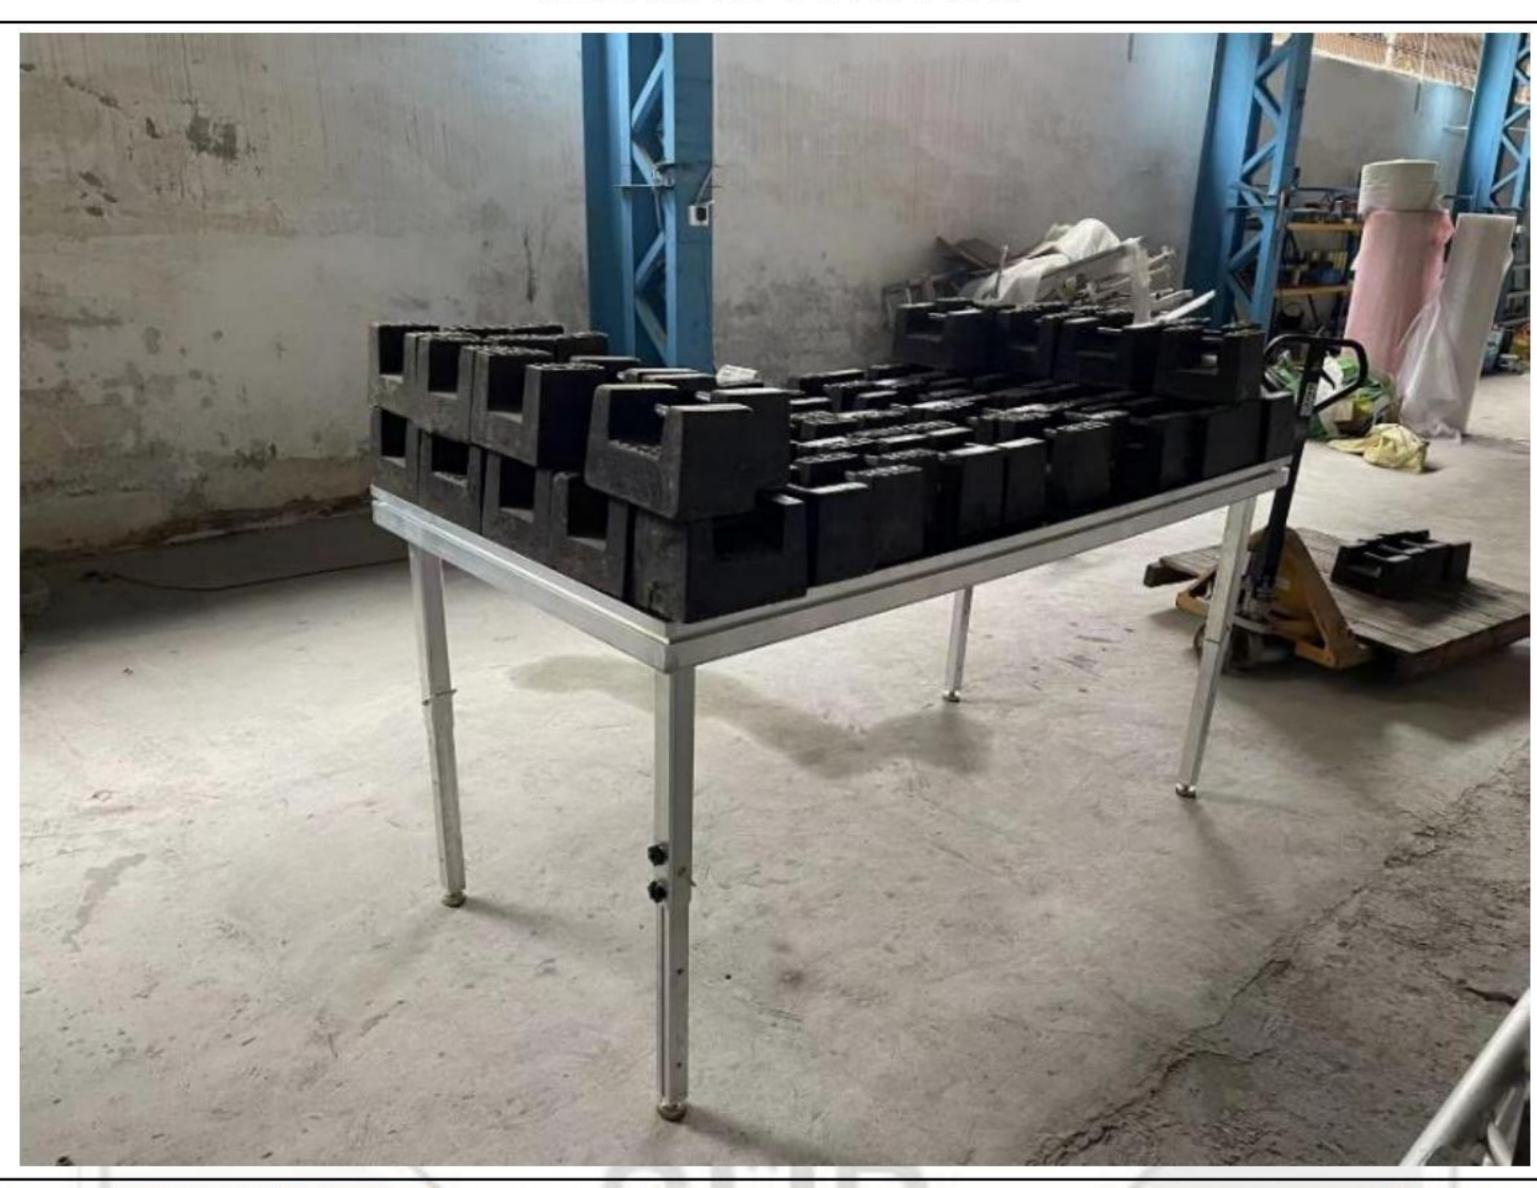
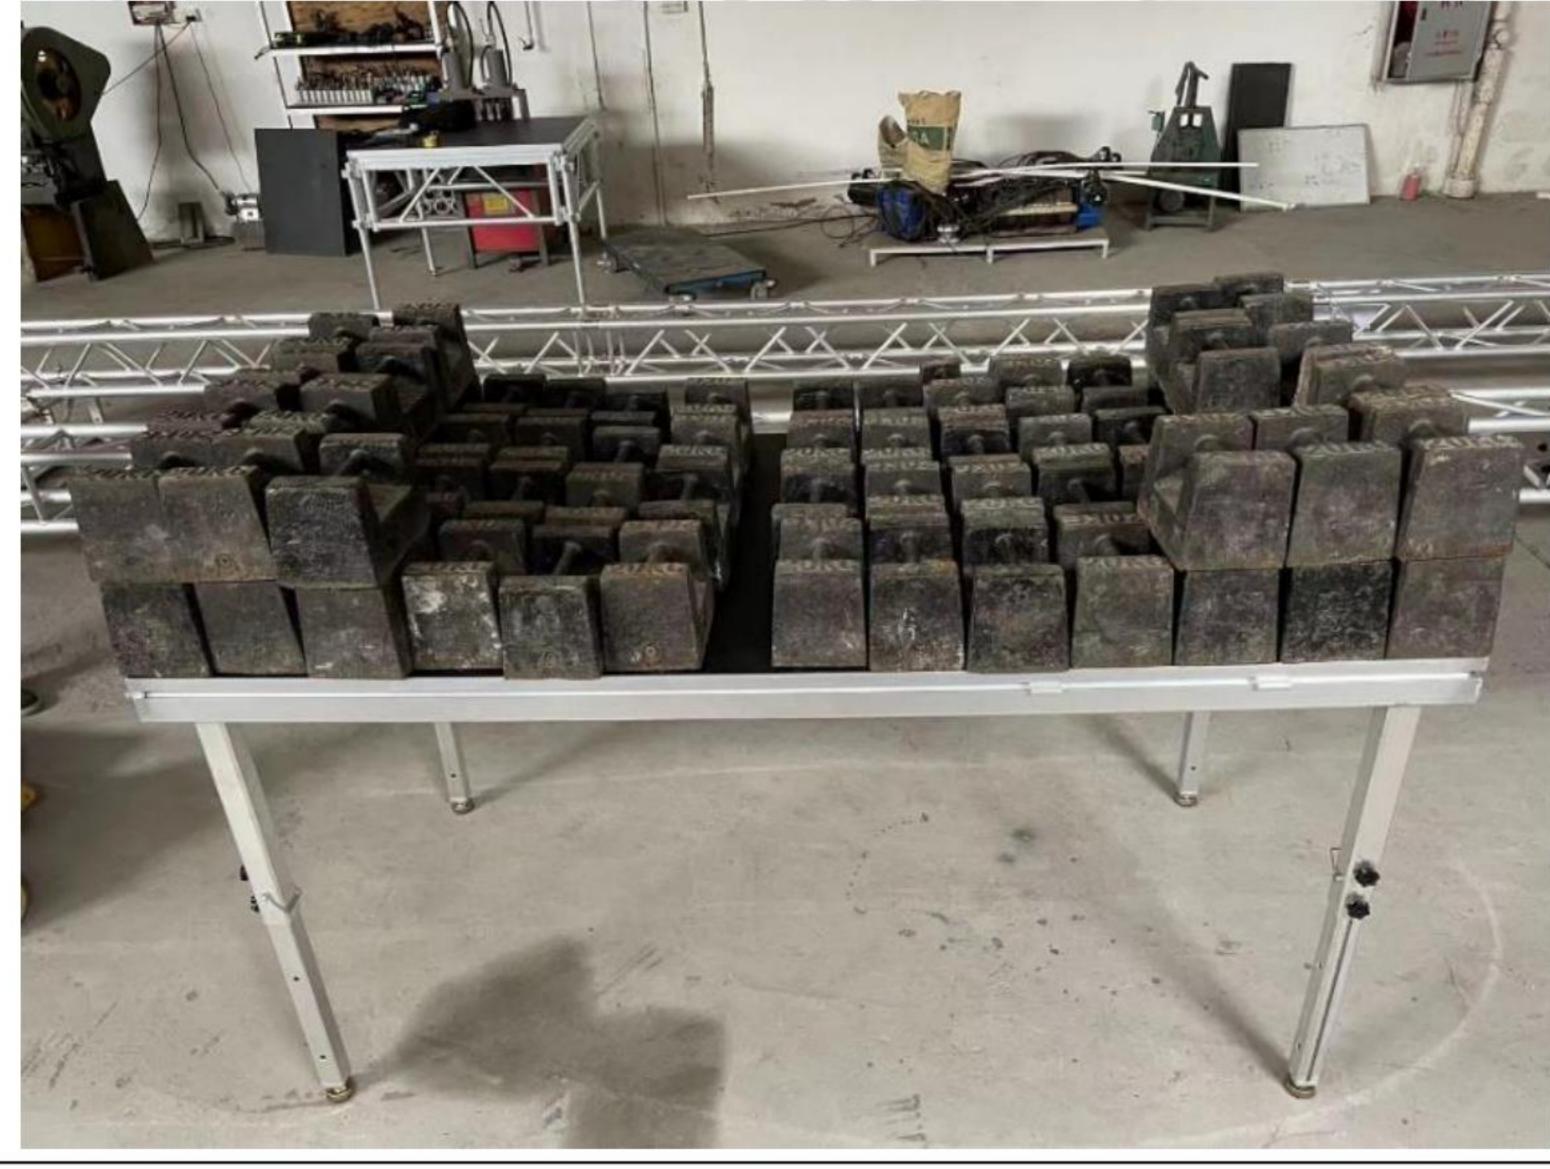
TESTING PHOTOS

Test item	Requirement ~ Test	Measuring result ~ Remark	Verdict
Loading test	The tested loads 1400kg were placed on the surface of the test sample. Test duration: 30min. Check if any damage during and after test.	No obvious deformation and damage were found after test.	
	Oncor if any damage daming and arter toot.	Details see below testing photos
